LEFT ELEVATION

PERSPECTIVE RIGHT FRONT

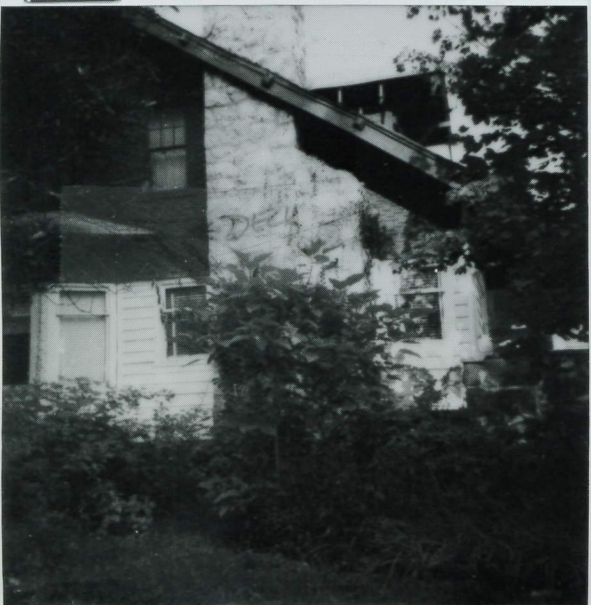
Side showing stairs + deck  
will be almost completely  
obscured from view  
(Before)

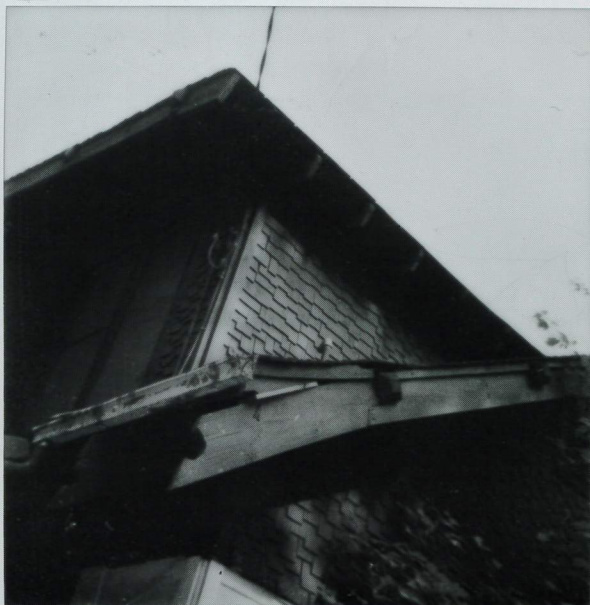
Rear, 1402 showing rotten, sawed  
and broken rafters  
(Before)

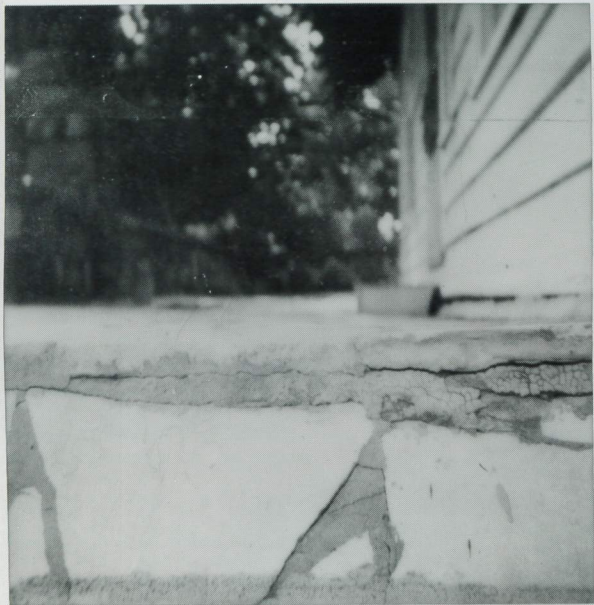
Side 1402 showing 6"  
drop in porch - wrong  
direction  
(Before)

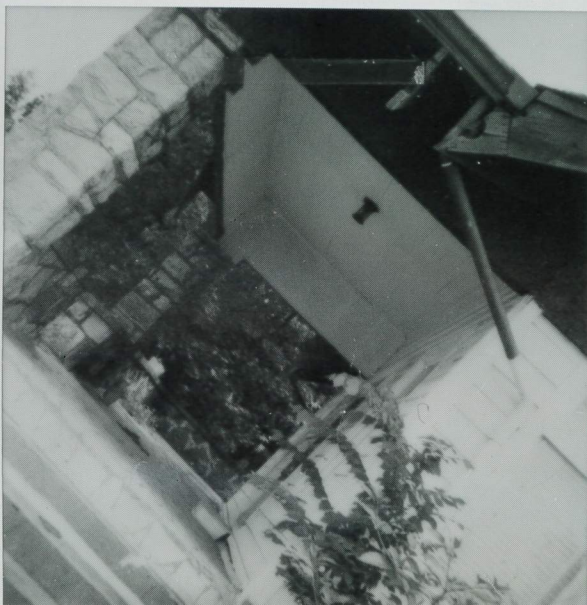
Another side view 1402 showing poor roof  
structure + badly sunken porch  
(Before)

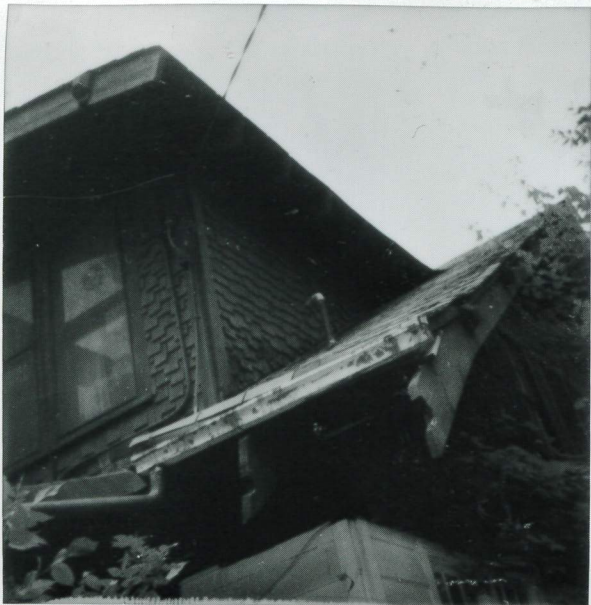
Other side rear 1402 Showing broken, crooked & sawed rafters

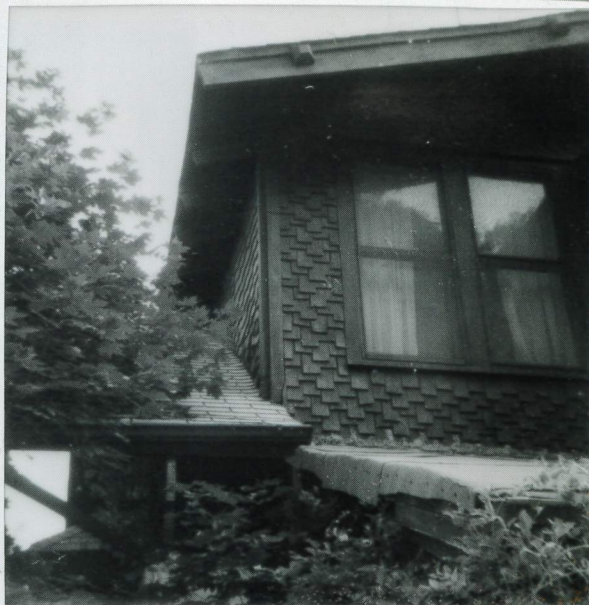
Rear 1402 Showing poor const. rear porch & sawed rafters plus crooked construction

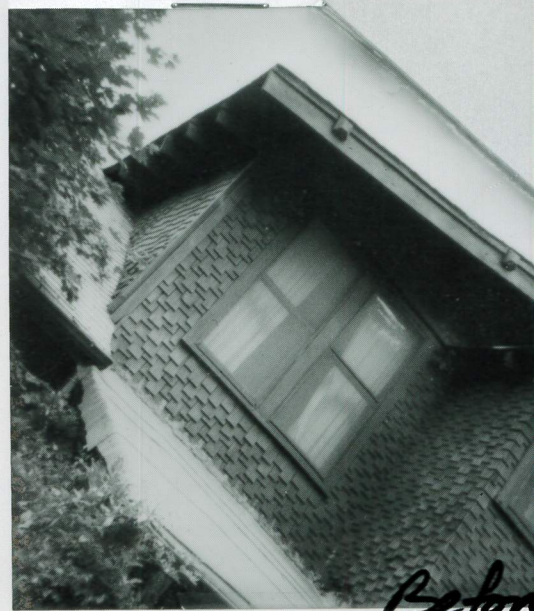
NOTE RAFTER ALL SAWED OFF / OTHERS ROTTED  
KNOTE roof line

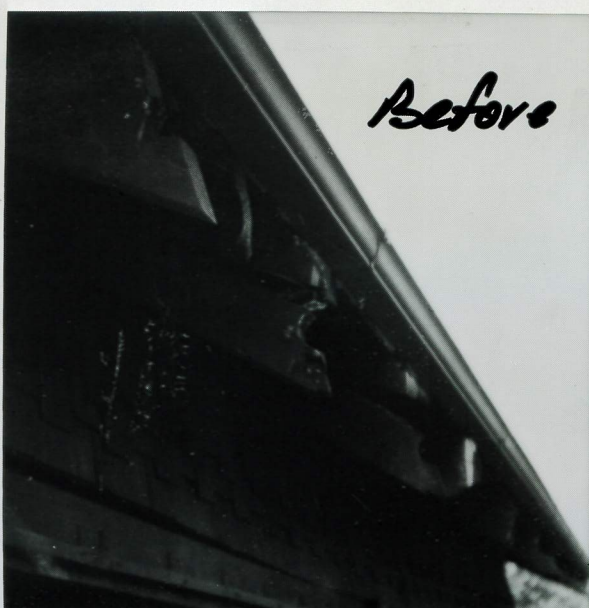
CLOSE UP ends of rotted rafters-1402

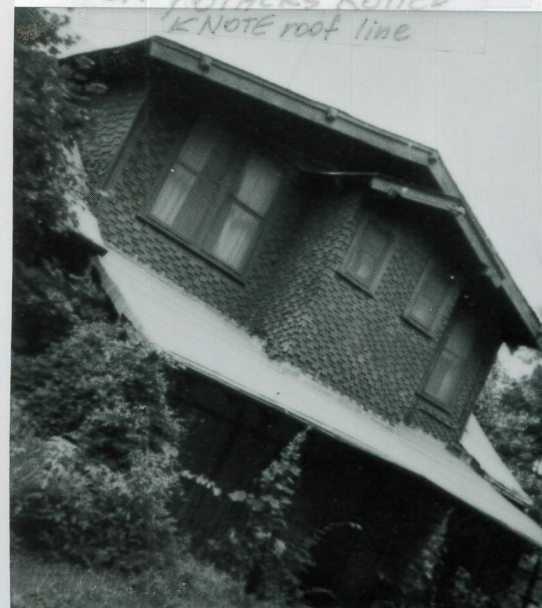
1402 Rear  
Porch not says badly

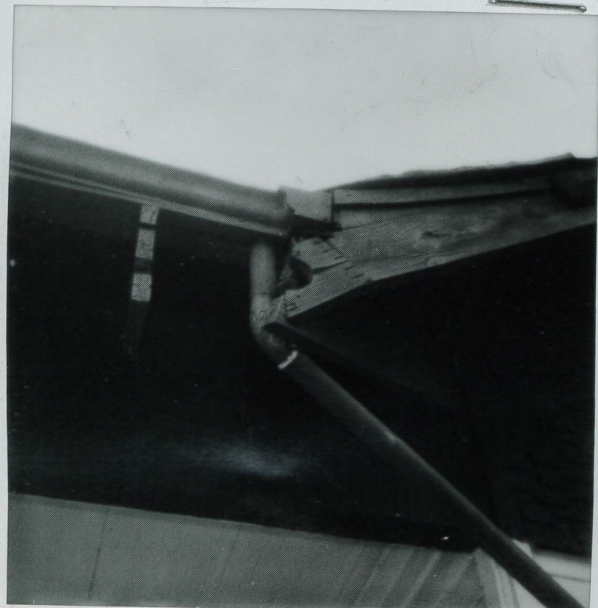
Side 1402, Porch structure

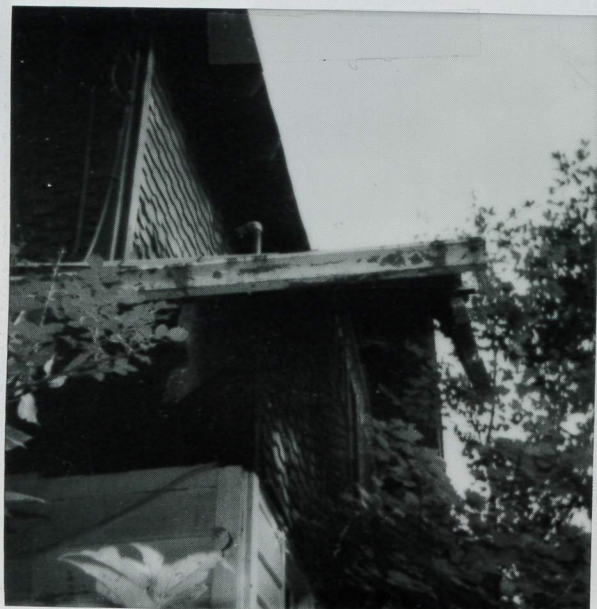
Rear 1402 showing ends "skewed" & bad cond.

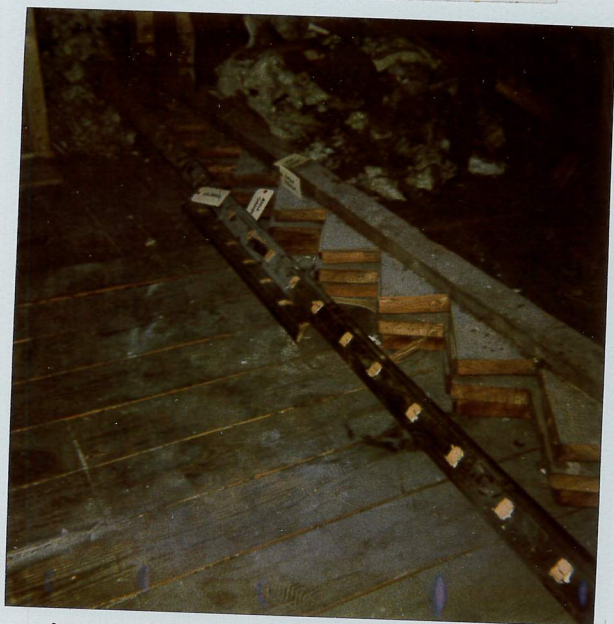
Handrails + stringers in place  
in attic. All tagged.

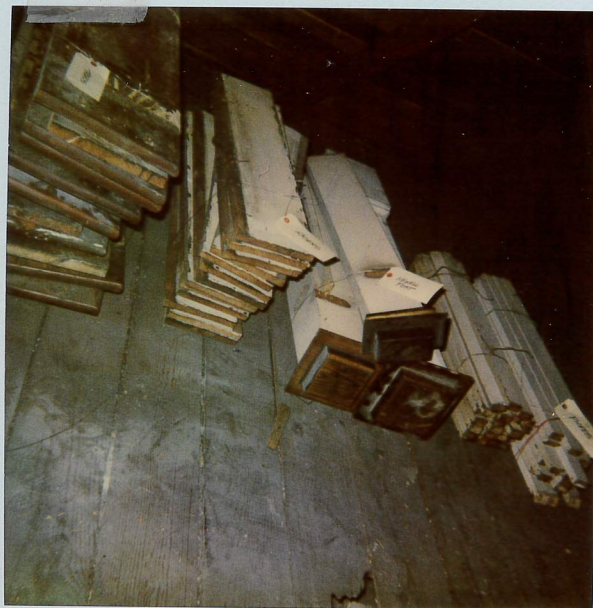
Treads, risers, newell posts  
and pickets in storage area  
in attic. All tagged.
